# **AFTER ACTION REPORT:**

## **WASTE MANAGEMENT AREA 15 – SITE INVESTIGATION AND REMOVAL ACTION**

**PLUM ISLAND ANIMAL DISEASE CENTER  
SUFFOLK COUNTY, NEW YORK**

**August 2007**

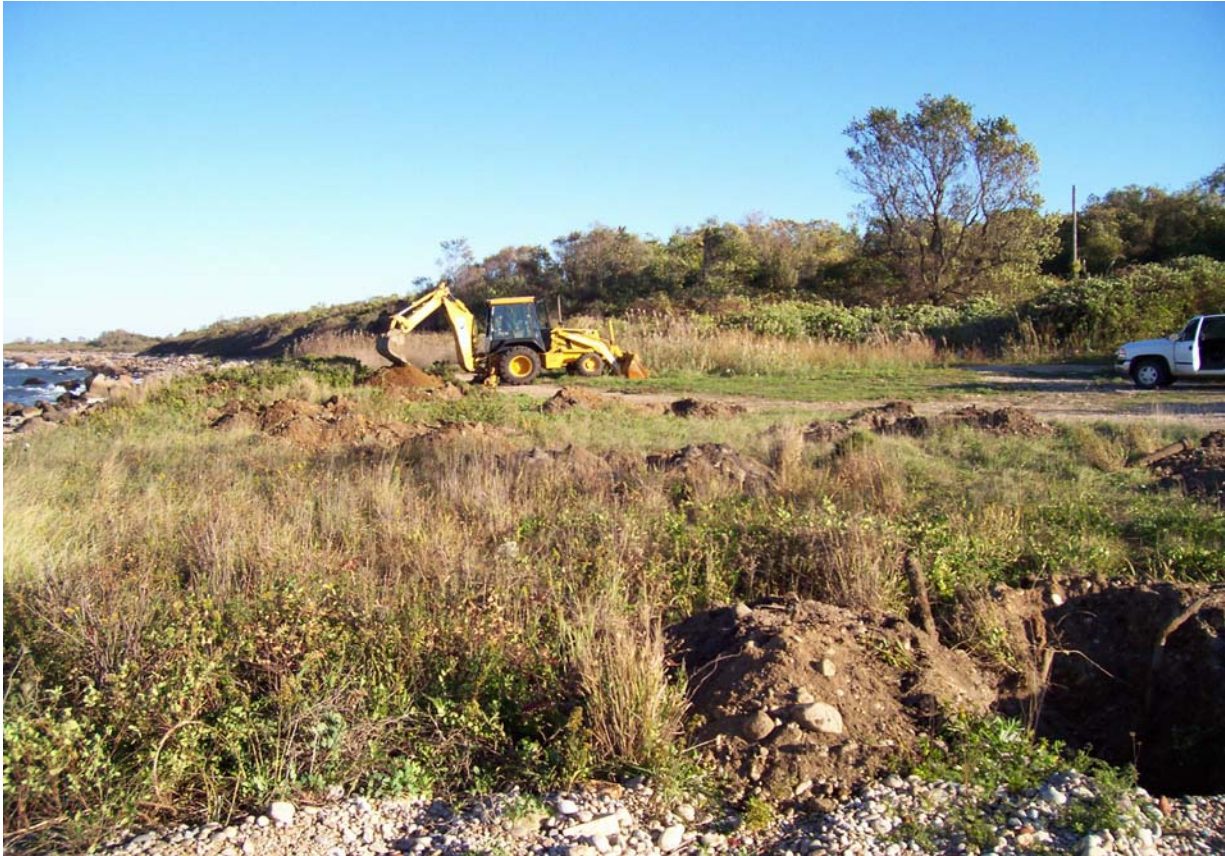
**Figure 15 – Test pitting action to characterize the nature and extent of landfill deposits in the central and western portions of WMA 15.**

Test pitting activities were initiated on October 17, 2005 and completed the following day. In all, 24 individual test pits were excavated within the footprint of the WMA. The pits were assigned alphabetic identifiers and their contents were described in a field notebook maintained by the investigatory staff. Each of the pits was created using a backhoe bucket and were dug to an average depth of three (3) to four (4) feet bgs. The horizontal dimensions of pits measured approximately two (2) feet wide and six (6) feet long. Figure 4 provides a spatial presentation of the pit locations relative to the footprint of the site. Table 1 briefly describes the contents observed in the exhumed overburden or in the sidewalls of each pit. No removal activities were conducted in concert with this action. The purpose of the test pitting exercise was strictly to ascertain the subsurface contents of the landfill and to delineate, if possible, the horizontal and vertical extent of any wastes contained therein. Representative photographs documenting this action are provided in Appendix A.

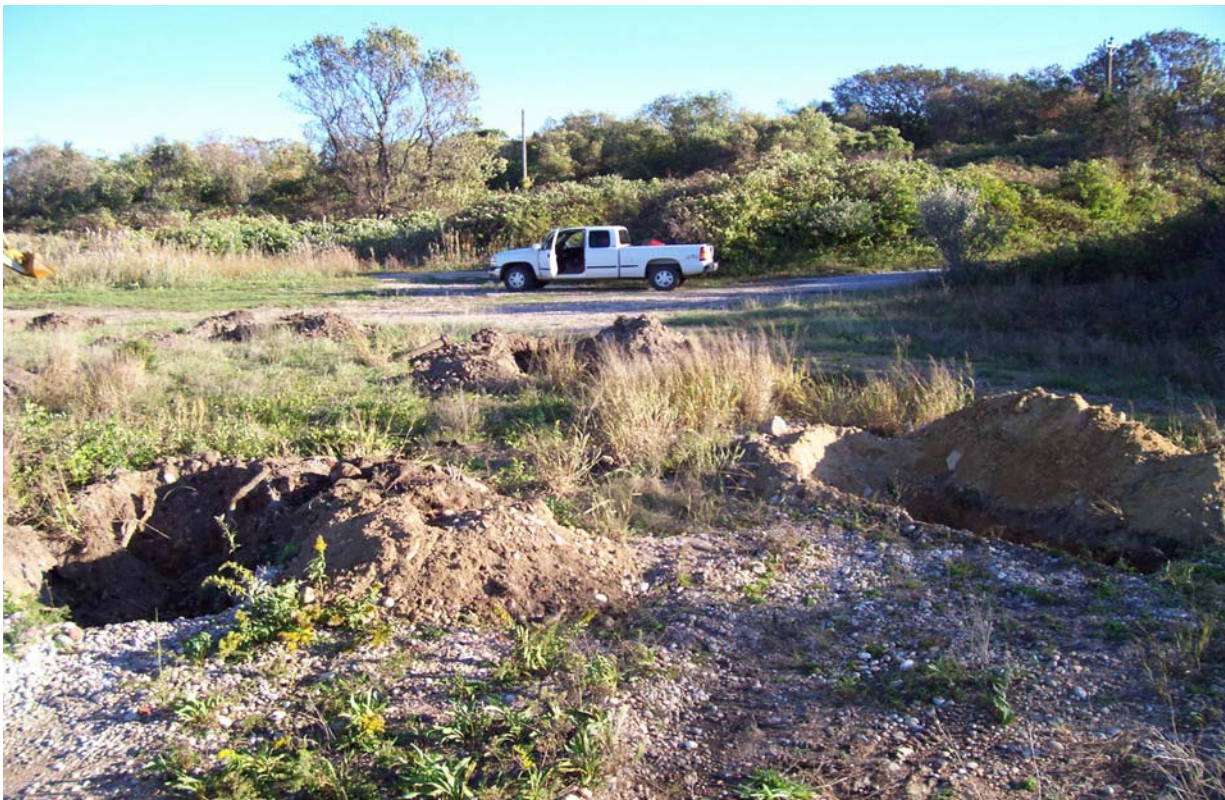
**Figure 16 - Typical view of test pits in the western portion of WMA 15.**

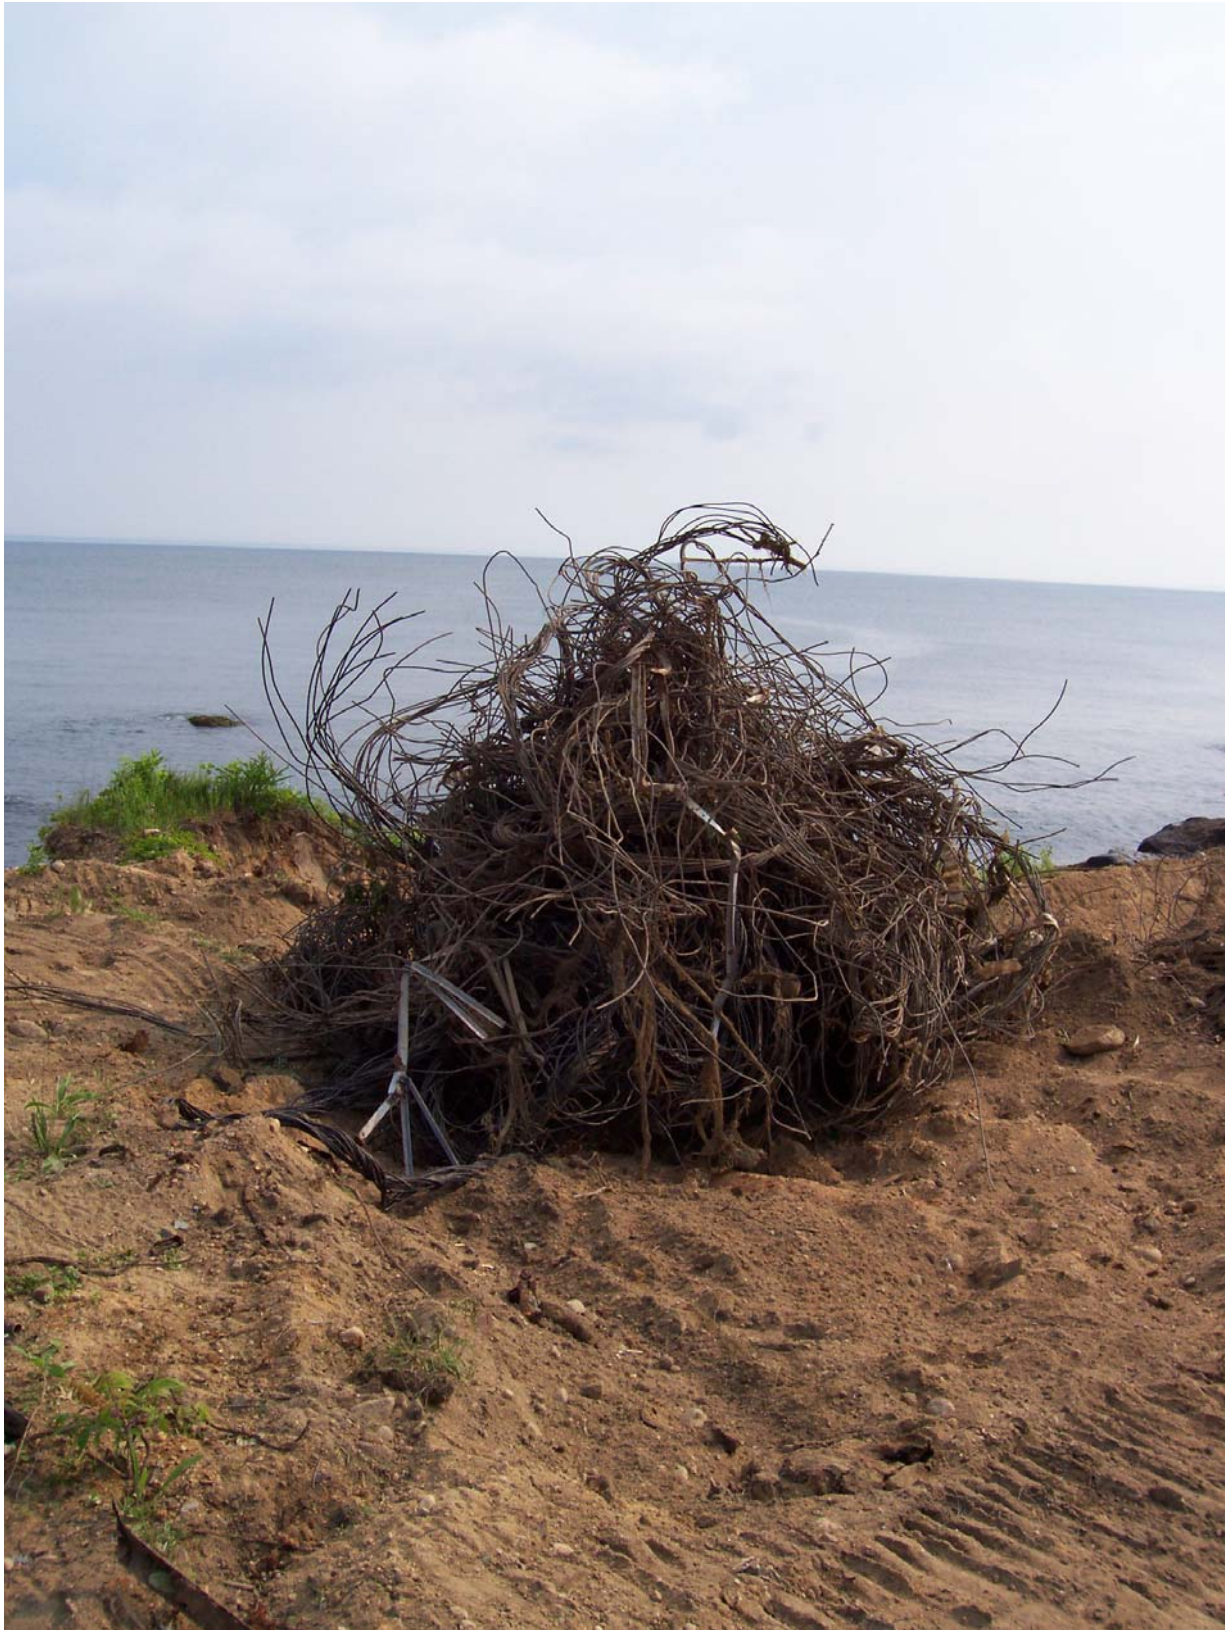
eastern portions of the site was heavy gauge wire/cable. This wire, which was roughly the diameter of a heavy gauge pencil, was found co-mingled with the drum carcasses. The original source and/or age of this material was unclear, but its presence among the drum carcasses, and the fact it was buried, seemed to suggest it was placed at WMA 15 by USDA-ARS. An example of the volume of the wire recovered from

**Figure 17 - View of some of the scrap wire exhumed with drum carcasses from the eastern portion of WMA 15.**

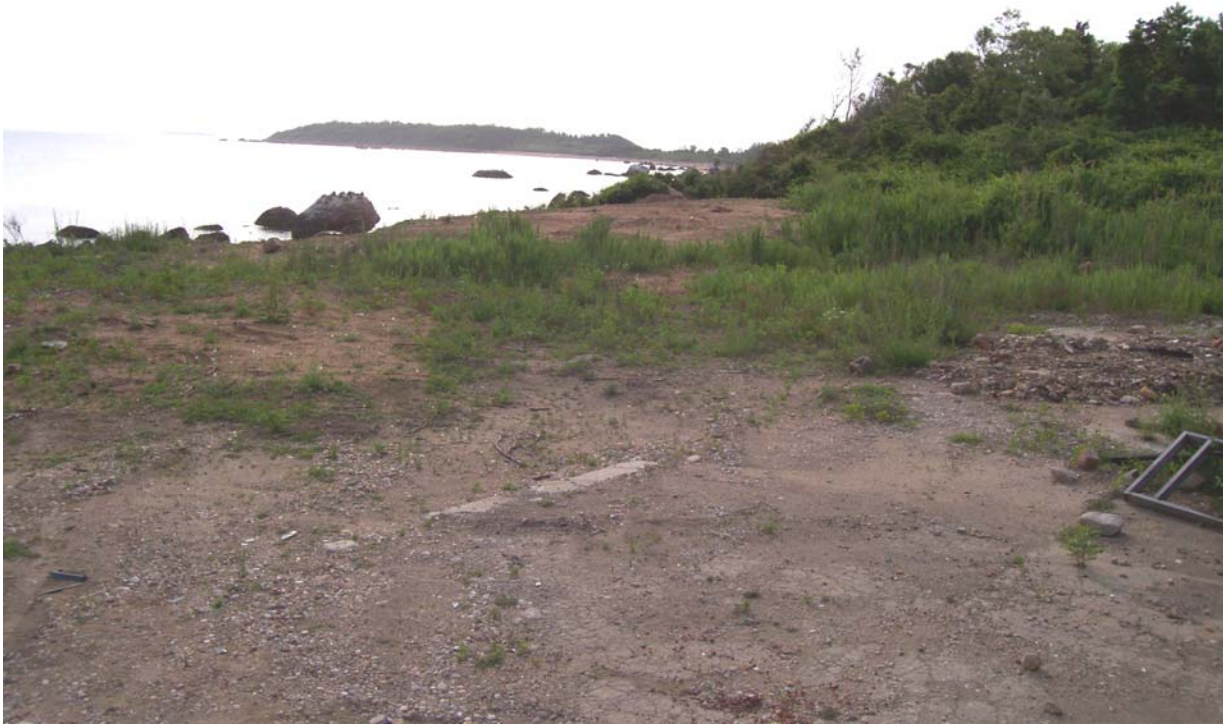
**Figure 18 - Post-restoration view of the eastern half of WMA-15. The barren soil in the mid-frame portion of the image marks the site of the former drum carcass burial ground. Native vegetation cover is quickly establishing itself over this scarred area (June 2007).**

Based on prior experience, no effort to artificially establish vegetative cover atop these disturbed areas were initiated. The introduction of non-native grass seed to this sandy, coastal environment has been found to be largely unsuccessful without extensive maintenance. Instead, Entech has observed that the natural restorative properties of native grasses and ground cover shrubs quickly establish themselves in these coastal environments and adequately protect disturbed areas from the threat of destabilization and erosion. Subsequent inspections of these areas have shown that native cover is returning and no significant soil erosion effects have been encountered.
